Flood Investigation Report

Stoke Goldington – 27th May 2018 Flood Event

Milton Keynes Council

December 2018

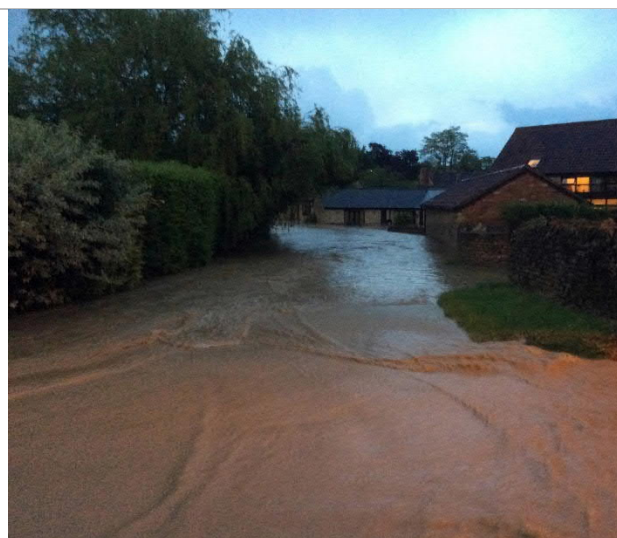
Figure 3-1: View down Orchard Way from junction with Dag Lane (Source: local resident)

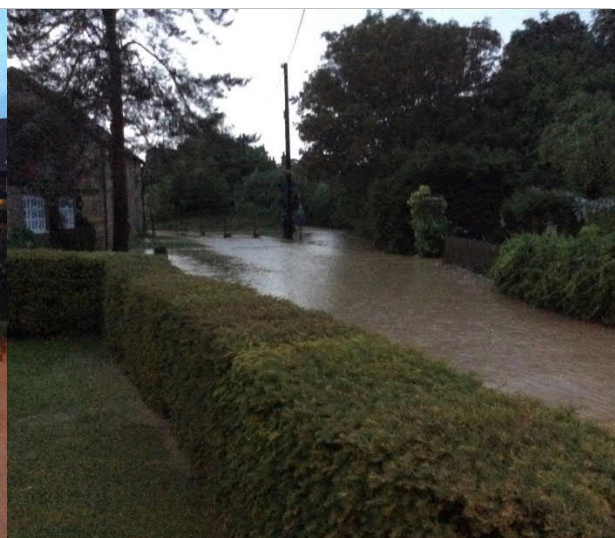
Figure 3-2: View north east from junction of Orchard Way and Dag Lane (Source: local resident)

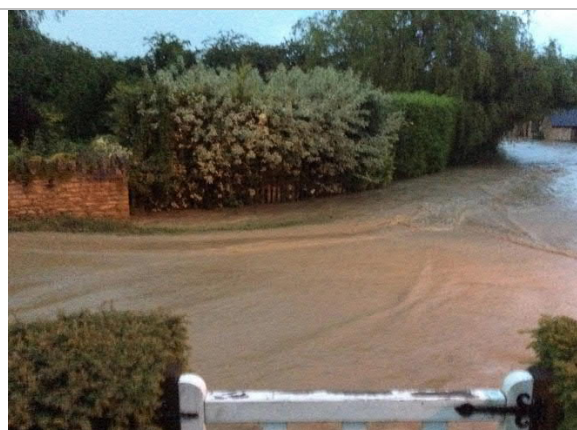
Figure 3-3: View of overwhelmed watercourse adjacent to property boundary on far side of road (Source: local resident)

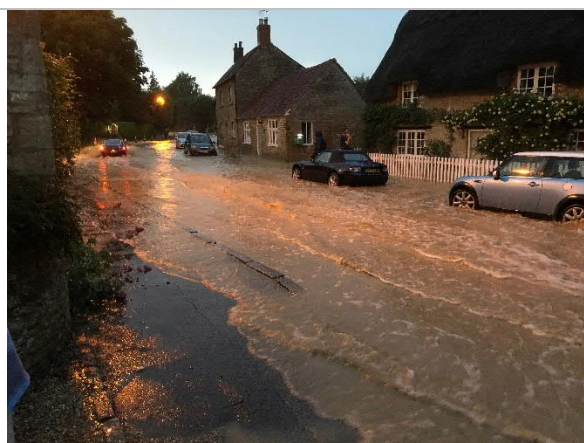
Figure 3-4: View of High Street looking north (Source: local resident)

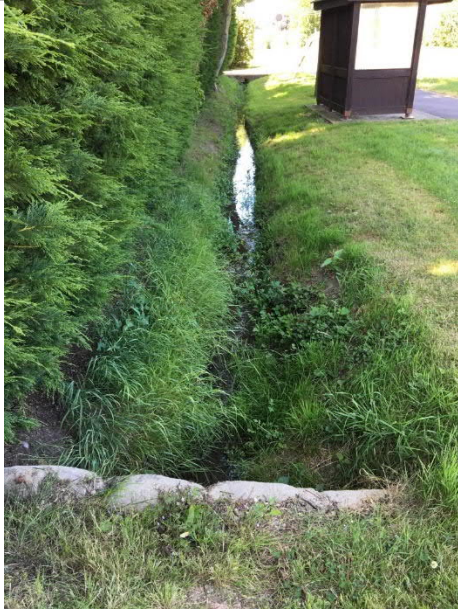
During the flood event that occurred in 2007, multiple properties along the southern area of the High Street experienced flooding. During the site visit undertaken on 27th June 2018, it was observed that there was a ditch in place on the south west side of the High Street, immediately north of Town End Crescent. The upstream sections of this appeared in good condition (see Figure 3-6). The part of the ditch further downstream is noticeably older and is likely to have been part of the original alignment of the water course (see Figure 3-7).

Figure 3-6: Looking downstream along the newer section of ditch from the upstream end (photo taken 27/6/18)

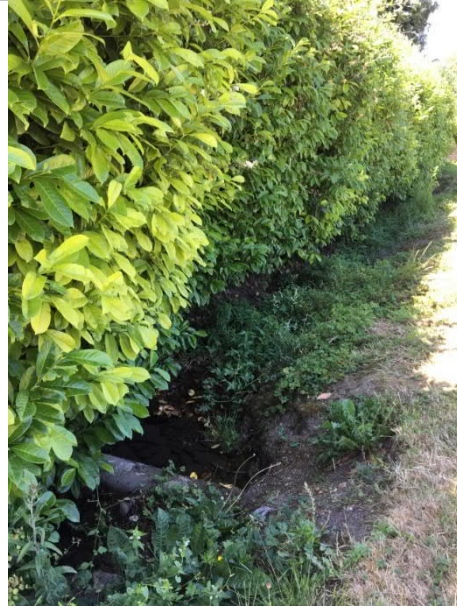
Figure 3-7: Older section of ditch with service crossings (photo taken 27/6/18)

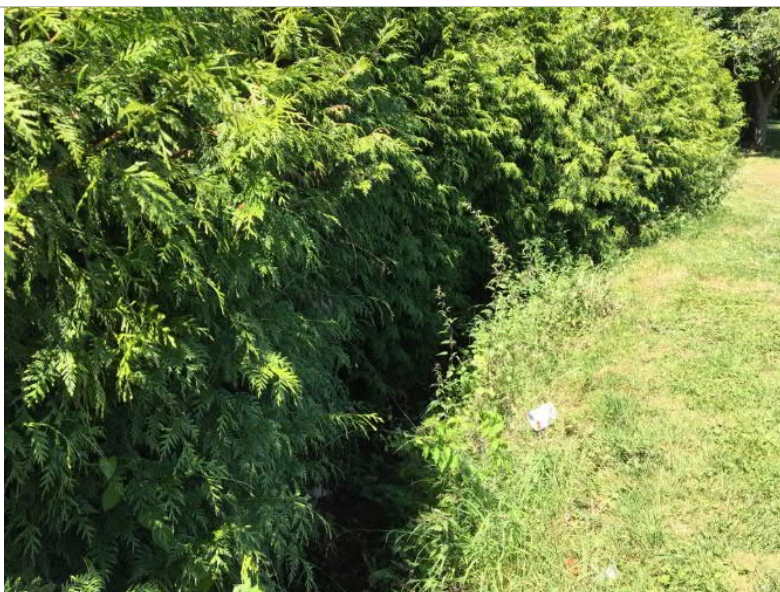
This open channel becomes culverted for a short distance underneath the High Street before becoming an open channel again along the boundary of the field adjacent to the Village Hall. This open channel is overgrown and thus its potential capacity and ability for conveyance is reduced (see Figure 3-8). A small outfall was seen on the west side of this channel which is understood to be the culvert outfall from the stream adjacent to Ram Alley.

Figure 3-8: Vegetated channel along boundary of field adjacent to Village Hall (photo taken 27/6/18)

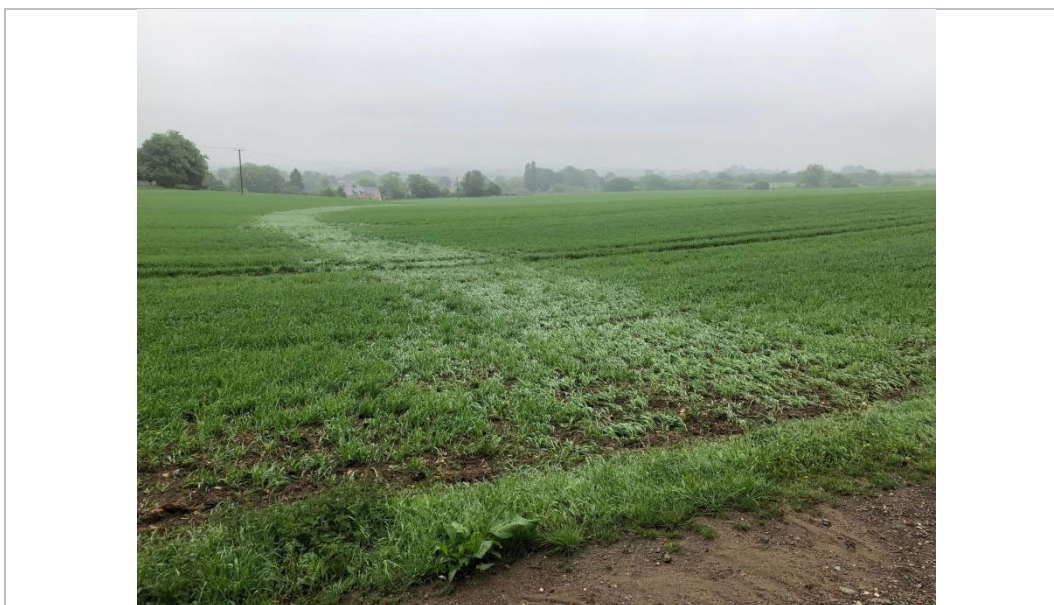
A flow path along Dag Lane (culverted watercourse and runoff from the fields to the south of the Church of Saint Peter) was identified from local resident video footage of Dag Lane during the 27th May 2018 flood event which indicated that there was a substantial flow along the road towards the direction of Orchard Way. This flow path was further evidenced by photos taken of the field to the south of the Church of Saint Peter following the flood event (see Figure 3-12). This flow path was not identified in the flood investigation undertaken for

Stoke Goldington following the 2007 flood events and therefore no works were proposed to manage the runoff from this location.

Figure 3-9: Evidence of flowpath in field to the south of the Church of Saint Peter (Source: local resident)

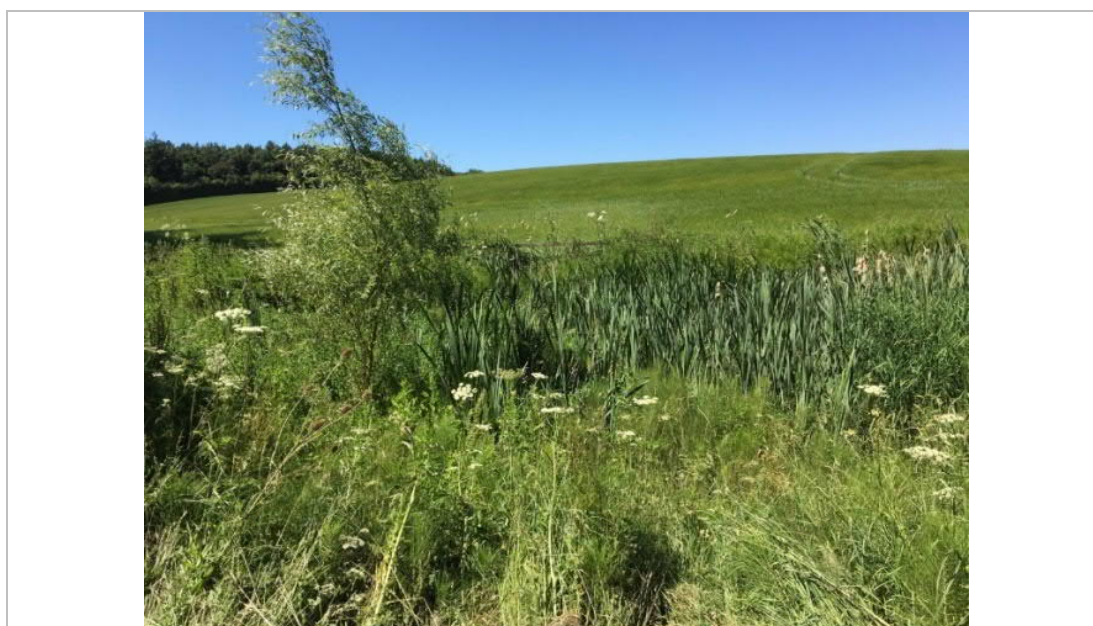
Another flood risk management measure implemented was a flood storage area upstream of Dag Lane, comprising 3 consecutive bunded storage areas. This area was visually inspected during the site visit on the 27th June 2018 (see Figure 3-10). On this date the storage areas

were seen to be vegetated. It was possible to identify one of the storage ponds which appeared to be an offline storage area with a separate inlet from the watercourse that would function to divert flow into the pond when the water level in the watercourse increased. Due to the vegetation growth it was not possible to identify the other storage areas which were understood to have been installed. It is identified in the MKC record of drainage works that the bunds were damaged by heavy vehicle crossing prior to 2018 which had reduced the flood capability of these measures. MKC have designed a capital maintenance scheme to reinstate the damaged sections of the bunds which will be implemented in 2019. These works will implement three new concrete grass crete vehicle crossing points making them more robust to withstand heavy vehicle use.

Figure 3-10: Vegetated Flood Storage Area upstream of Dag Lane (photo taken 27/6/18)
