CLIENT: **BERKLEY ST JAMES**

This document is provided regarding the submission of a hybrid planning application on behalf of Berkeley St James for the Milton Keynes East (MKE) development on the land to the east of Milton Keynes and the M1 motorway and south of Newport Pagnell in Buckinghamshire as shown in **Figure 1-1**, hereby referred to as ‘the Site’.

**Tree Survey Constraints Plans**

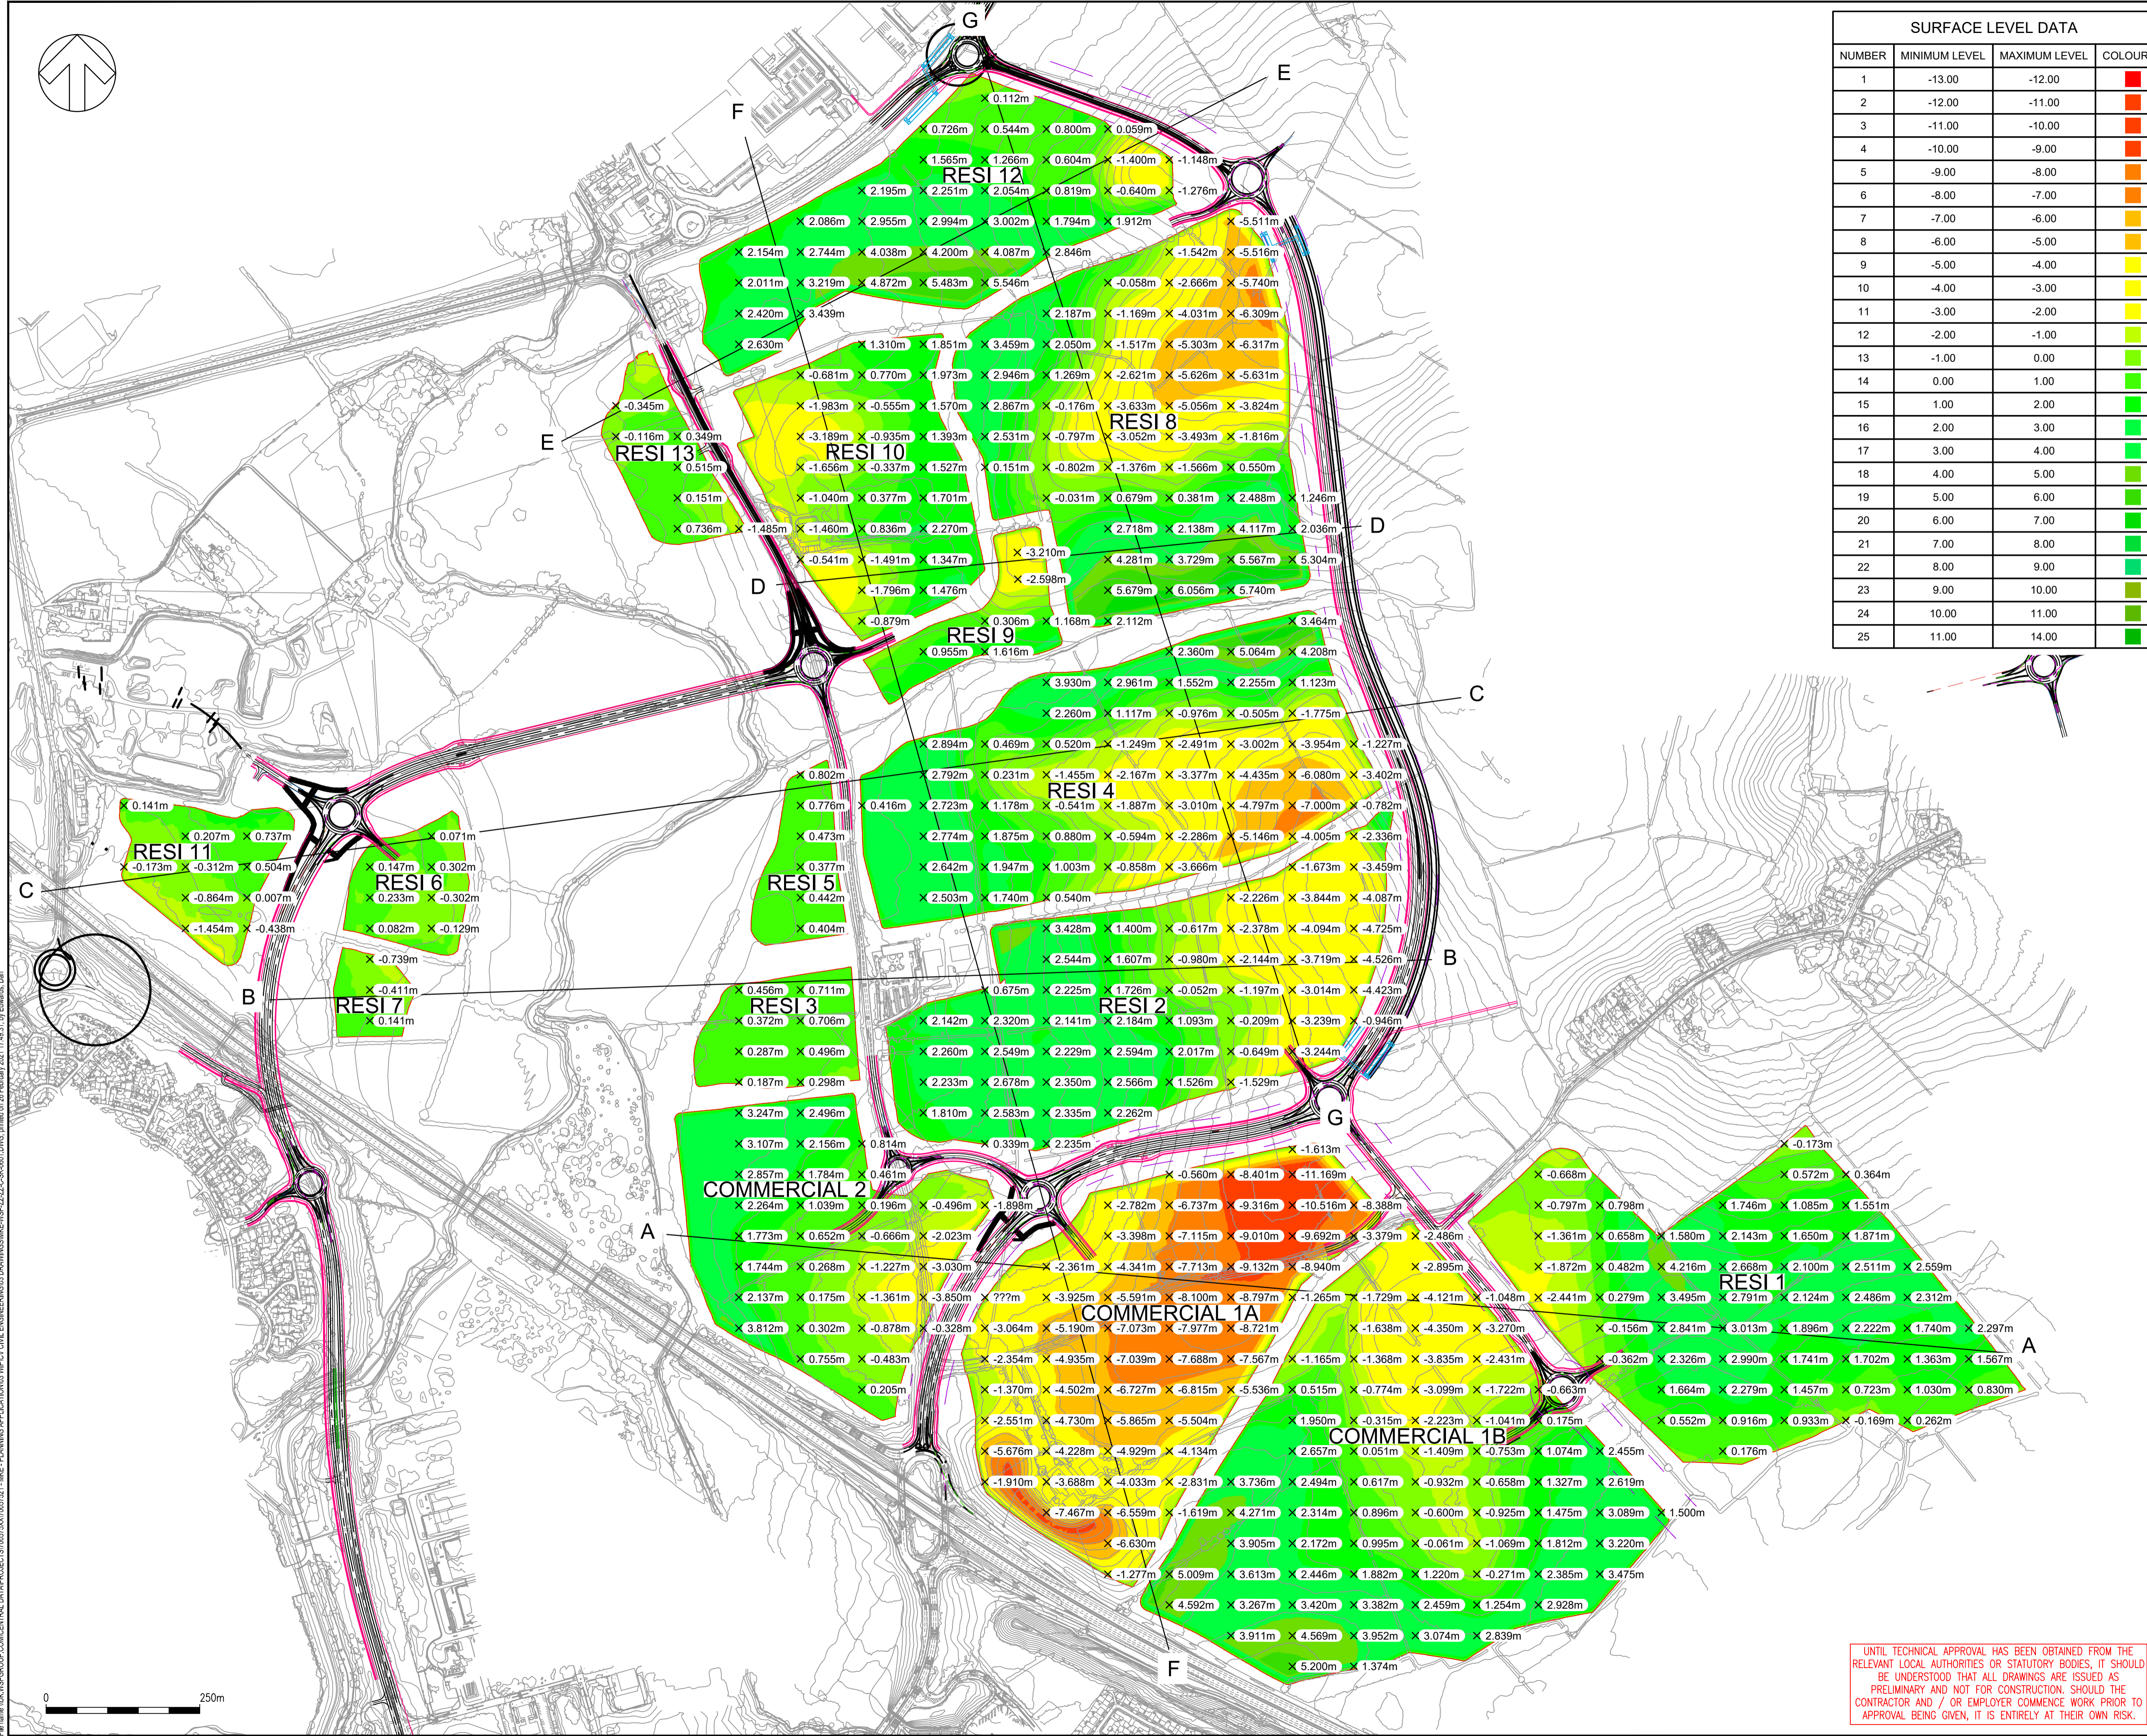
- THIS PLAN SHOWS A CUT AND FILL VOLUME COMPARISON BETWEEN THE FOLLOWING TWO SURFACES: MKE TOPSOIL GROUND VS MKE PLOT LEVELS. 300MM TOPSOIL ALLOWANCE MADE.

- NO ALLOWANCE HAS BEEN MADE FOR FOUNDATION, PIT, TRENCH ARISING OR BACKFILLING WITH SELECTED MATERIALS FOR RETAINING STRUCTURE CONSTRUCTION.
  - THE PLAN CONTOURS REPRESENT THE ELEVATION DIFFERENCE BETWEEN THE TWO SURFACES, WITH POSITIVE AND NEGATIVE CONTOUR VALUES REPRESENTING AREAS OF FILL AND CUT RESPECTIVELY.

-0.598	CUT DEPTH
0.588	FILL DEPTH

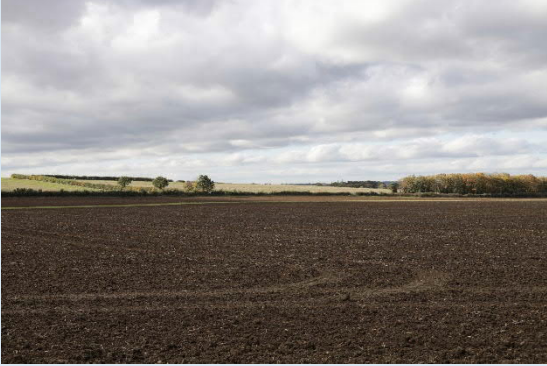
Site Reference	Commentary						
	<div style="display: flex; justify-content: space-around;"> <div style="text-align: center;"> <p><b>Figure 3-3 - Daytime (west)</b></p>

<p><b>L3</b></p>	<p>The viewpoint is located on the edge of an agricultural field c. 750m east of the A509 and surveyed to record the baseline conditions to support the ecological assessment. Views were recorded looking towards the west in the direction of the A509 and further afield towards the M1 motorway and eastern outskirts of Milton Keynes.</p> <p>Immediately to the south of the viewpoint there is a dense line of deciduous hedgerow and trees which continues to the west screening views to the south and south-west. Initial views to the west are of a large undulating agricultural field and behind the brow of the field, vehicles using the A509, which sits lower than the viewpoint, are visible. Behind the A509 the ground rises, and large industrial buildings can be seen interspersed between lines of dense deciduous trees. The first-floor windows of a residential property can be seen along with a large bank of deciduous trees bounding the field to the north-west. There are no sources of artificial lighting visible during the day.</p> <p>During the night the viewpoint appeared dark. The distant landscape appeared mainly dark but for intermittent lighting visible in the direction of the industrial buildings and residential property noted during the day. Sky glow appeared minimal and could be seen reflecting off the clouds above Milton Keynes to the west.</p> <p>Baseline lighting levels and views are predicted to be similar for viewpoints <b>L1</b> and <b>L2</b>.</p>

<b>Viewpoint number / description</b>	<b>Baseline conditions / nearby development</b>	<b>Predicted impacts</b>
<b>L3</b> Track (agricultural field boundary) – East of A509	<ol style="list-style-type: none"> <li>1. No nearby artificial lighting and viewpoint will appear dark.</li> <li>2. Located within redline boundary, near to development parcels (secondary school and residential)</li> <li>3. Will be located adjacent to lit environment.</li> </ol>	<ol style="list-style-type: none"> <li>1. As the receptor is located adjacent to lit development, lighting levels could exceed ILP GN08 limitations.</li> <li>2. Implementing a suitable unlit buffer and considering the location of luminaires in relation to sensitive features will reduce spill light.</li> </ol>
<b>L7</b> Track (agricultural field boundary) – South of Newport Road	<ol style="list-style-type: none"> <li>1. No nearby artificial lighting and viewpoint will appear dark.</li> <li>2. Located within redline boundary, near to proposed Grid Road and residential.</li> <li>3. Will be located within a lit environment.</li> </ol>	<ol style="list-style-type: none"> <li>1. As the receptor is located adjacent to the lit system of grid type roads, lighting levels could exceed ILP GN08 limitations.</li> <li>2. Implementing a suitable unlit buffer and considering the location of luminaires in relation to sensitive features will reduce spill light.</li> </ol>

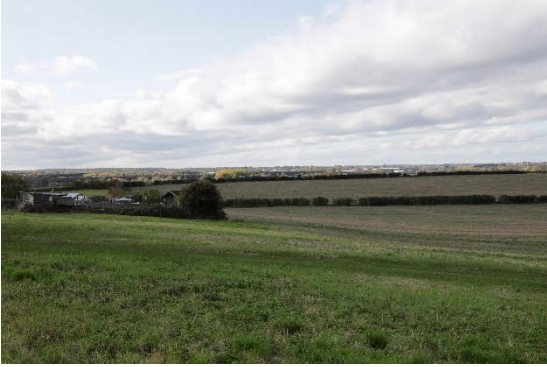
Site Reference	Commentary						
	<div style="display: flex; justify-content: space-around;"> <div style="text-align: center;"> <p><b>Figure 3-5 - Daytime (north-west)</b></p>

</div> </div>						
<p><b>L5</b></p>	<p>The viewpoint is located on Newport Road in the village of Moulsoe and has been surveyed to inform the LVIA. Views are recorded looking north-west towards Newport Pagnell.</p> <p>To the north-west there are views across open fields with deciduous hedgerow boundaries. The landform initially falls sharply with the viewpoint looking across from a highpoint and then gradually rises towards Milton Keynes. Distant views are mainly of dense deciduous vegetation with intermittent views of large industrial buildings visible above the vegetation.</p> <p>There are localised views to the north-west of the rear gardens of residential properties located on Newport Road with some decorative lighting visible within the garden. Further residential properties can be seen adjacent to the viewpoint to the north-east and south-east.</p> <p>Artificial lighting is visible along Newport Road, attached to utility poles. Luminaires with high pressure sodium light sources are mounted at approximate heights of 4m, with five-degree tilts. The spacing of the luminaires is intermittent however there is one luminaire located next to the residential property noted to the north-east of the viewpoint.</p> <p>During the night-time survey the viewpoint appeared dark as indicated by the levels of recorded illuminance. There are localised views of the lighting along Newport Road which appeared yellow in nature along with light spilling through some of the residential property windows to the north-west.</p> <p>There are distant views of artificial lighting visible above the dense vegetation noted during the day likely to be located near to the industrial buildings and suburban residential areas of Milton Keynes and Newport Pagnell. Lighting appeared mainly white in colour. Sky glow was apparent in the direction of the two towns, medium in intensity with white and orange appearance.</p>						
	<p><b>Recorded Illuminance (in lux)</b></p> <table style="width: 100%; border: none;"> <tr> <td style="width: 33%;"><b>Ground</b> – 0.04</td> <td style="width: 33%;"><b>North</b> – 0.02</td> <td style="width: 33%;"><b>East</b> – 0.02</td> </tr> <tr> <td></td> <td><b>South</b> – 0.06</td> <td><b>West</b> – 0.04</td> </tr> </table>	<b>Ground</b> – 0.04	<b>North</b> – 0.02	<b>East</b> – 0.02		<b>South</b> – 0.06	<b>West</b> – 0.04
<b>Ground</b> – 0.04	<b>North</b> – 0.02	<b>East</b> – 0.02					
	<b>South</b> – 0.06	<b>West</b> – 0.04

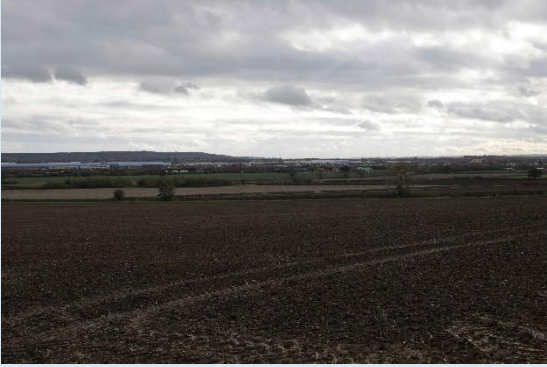
Site Reference	Commentary						
	<div style="display: flex; justify-content: space-around;"> <div style="text-align: center;"> <p><b>Figure 3-7 - Daytime (south-by-west)</b></p>

</div> </div>						
<p><b>L6</b></p>	<p>The viewpoint is located on a PRoW south-east of St Mary’s Church, Moulsoe and has been surveyed to inform the LVIA. Views are recorded looking south-by-west in the direction of the M1 motorway and south-eastern outskirts of Milton Keynes.</p> <p>The viewpoint is located on top of a hill overlooking Milton Keynes. There are initial views in the foreground of large open agricultural fields bounded by deciduous hedges and tree lines where the land gradually slopes down. The open view is broken by dense deciduous vegetation lining the M1 motorway, there are breaks in the vegetation where larger vehicles using the M1 can be seen. A small cluster of two-storey residential properties and industrial farm buildings can be seen in front of the M1. Behind the M1 the urban sprawl of Milton Keynes can be seen with a mixture of large industrial warehouses and residential buildings visible across the entire vista. Behind these urban features the landform appears to rise, and large clusters of deciduous trees located on the higher ground can be seen forming a backdrop to the town. Artificial lighting installations were not visible during the day.</p> <p>During the night-time survey no artificial lighting was noted near to the viewpoint which appeared dark with initial views across dark open fields. A large expanse of artificial lighting is visible from the urban area of Milton Keynes providing views of a mixture of white and yellow street lighting along with lit business signage attached to the industrial warehouses.</p> <p>Sky glow is visible in the direction of Milton Keynes, mildly intense appearing white and orange.</p>						
	<p><b>Recorded Illuminance (in lux)</b></p> <table style="width: 100%; border: none;"> <tr> <td style="width: 33%;"><b>Ground</b> – 0.05</td> <td style="width: 33%;"><b>North</b> – 0.01</td> <td style="width: 33%;"><b>East</b> – 0.02</td> </tr> <tr> <td></td> <td><b>South</b> – 0.06</td> <td><b>West</b> – 0.04</td> </tr> </table>	<b>Ground</b> – 0.05	<b>North</b> – 0.01	<b>East</b> – 0.02		<b>South</b> – 0.06	<b>West</b> – 0.04
<b>Ground</b> – 0.05	<b>North</b> – 0.01	<b>East</b> – 0.02					
	<b>South</b> – 0.06	<b>West</b> – 0.04

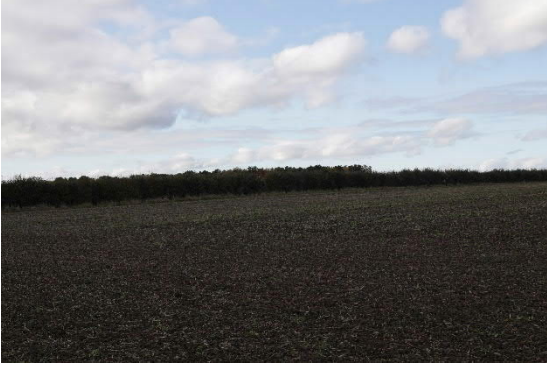
</div> </div>						
<p><b>L7</b></p>	<p>The viewpoint is located on the edge of an agricultural field c. 500m south of the village of Moulsoe and surveyed to inform the ecological assessment. Views are recorded looking west-north-west.</p> <p>Daytime views are of an open agricultural field which rises to the west-north-west and is bounded by dense deciduous vegetation approximately 2m in height. Onward views are screened by the vegetation and there is no visible artificial lighting infrastructure.</p> <p>The viewpoint appeared dark during the night-time survey, artificial lighting is not visible to the west-north-west due to the screening and topography near to the viewpoint. Medium intensity distant sky glow, white and orange in appearance and likely to be emanating from the towns of Milton Keynes and Newport Pagnell can be seen.</p> <p>To the north of the viewpoint, four high-pressure sodium (yellow in appearance) street lighting luminaires, previously noted at viewpoint 5 can be seen in the distance.</p>						
	<p><b>Recorded Illuminance (in lux)</b></p> <table style="width: 100%; border: none;"> <tr> <td style="width: 33%;"><b>Ground</b> – 0.02</td> <td style="width: 33%;"><b>North</b> – 0.01</td> <td style="width: 33%;"><b>East</b> – 0.01</td> </tr> <tr> <td></td> <td><b>South</b> – 0.02</td> <td><b>West</b> – 0.02</td> </tr> </table>	<b>Ground</b> – 0.02	<b>North</b> – 0.01	<b>East</b> – 0.01		<b>South</b> – 0.02	<b>West</b> – 0.02
<b>Ground</b> – 0.02	<b>North</b> – 0.01	<b>East</b> – 0.01					
	<b>South</b> – 0.02	<b>West</b> – 0.02					
	<div style="display: flex; justify-content: space-around;"> <div style="text-align: center;"> <p><b>Figure 3-9 - Daytime (west-north-west)</b></p>

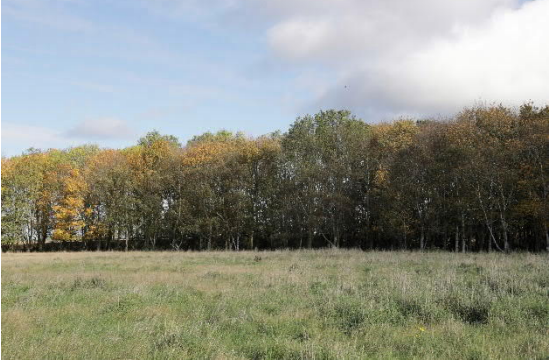
Site Reference	Commentary
	<div style="display: flex; justify-content: space-around;"> <div style="text-align: center;"> <p><b>Figure 3-13 - Daytime (north-east)</b></p>

L9	<p>The viewpoint is located within grassland between the sewage works and Milton Keynes Coachway, south of the M1 motorway and surveyed to inform the ecological assessment.</p> <p>Initial views looking north-east are of a flat grassed field bounded by a line of tall deciduous trees through which there are intermittent views of a short embankment and the M1.</p> <p>Although not clear during the day, road lighting located on the M1, Junction 14 slip road can be seen through the tree line during the night. The road lighting appeared yellow, indicative of high-pressure sodium lamps and light spilling onto the embankment and adjacent treeline was visible. Vehicle headlights were also visible. To the south-east of the viewpoint, white LED road lighting was visible, likely located on the A509. Although artificial lighting is visible, the viewpoint appeared dark as indicated by the recorded levels of illuminance. Sky glow was prominent in the direction of Milton Keynes, to the south of the viewpoint.</p>						
	<p><b>Recorded Illuminance (in lux)</b></p> <table border="0"> <tr> <td><b>Ground</b> – 0.04</td> <td><b>North</b> – 0.02</td> <td><b>East</b> – 0.03</td> </tr> <tr> <td></td> <td><b>South</b> – 0.05</td> <td><b>West</b> – 0.05</td> </tr> </table>	<b>Ground</b> – 0.04	<b>North</b> – 0.02	<b>East</b> – 0.03		<b>South</b> – 0.05	<b>West</b> – 0.05
<b>Ground</b> – 0.04	<b>North</b> – 0.02	<b>East</b> – 0.03					
	<b>South</b> – 0.05	<b>West</b> – 0.05

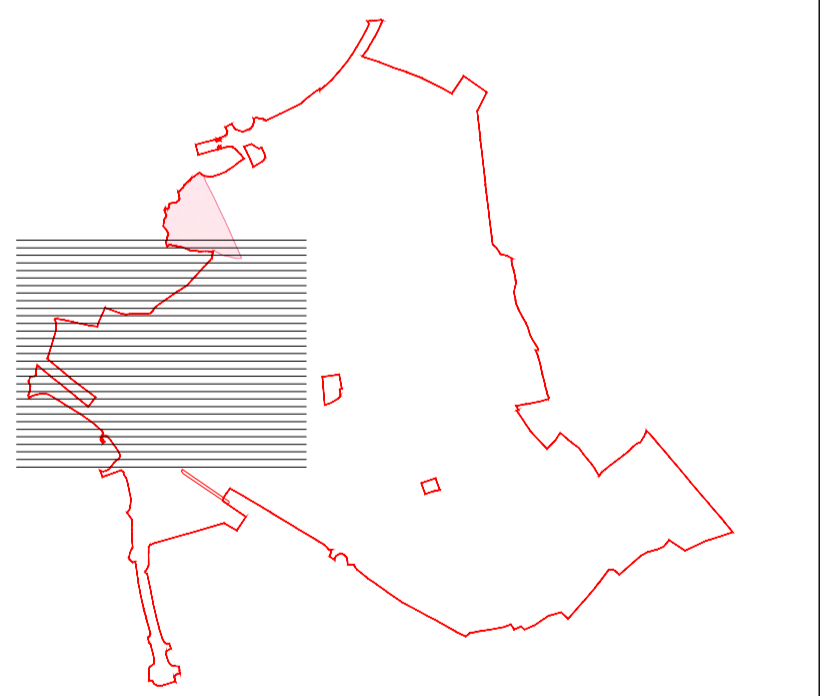
CLIENT: St James  
 PROJECT: Milton Keynes East - Trees  
 TITLE: Tree Survey Constraints Plan (Sheet 2 of 7)  
 SCALE AT A3: 1:2000  
 DATE: March 2021  
 2090.83 / 26

(Green circle)	Canopy extent of tree: Category A
(Blue circle)	Canopy extent of tree: Category B
(Grey circle)	Canopy extent of tree: Category C
(Red circle)	Canopy extent of tree: Category U

Note: Area of Tree Preservation Order taken from Milton Keynes Council 'Planning Constraints Map'

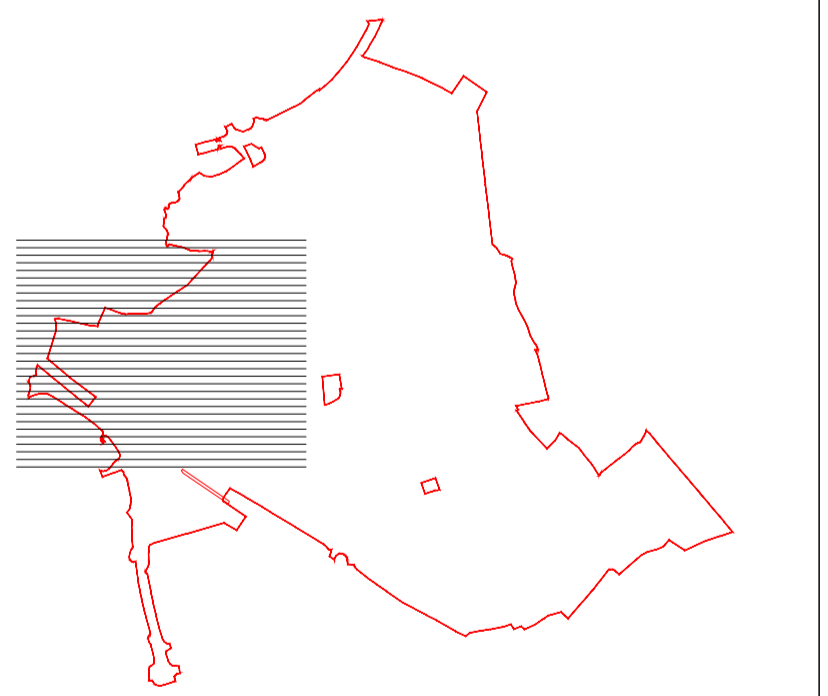
- Canopy extent of tree: Category A
- Canopy extent of tree: Category B
- Canopy extent of tree: Category C
- Canopy extent of tree: Category U

Note: Trees lost due to highway scheme are excluded from this plan. The removed trees/hedgerows/woodlands/group due to the highway scheme can be found on plans 2090.83\_32 - 45

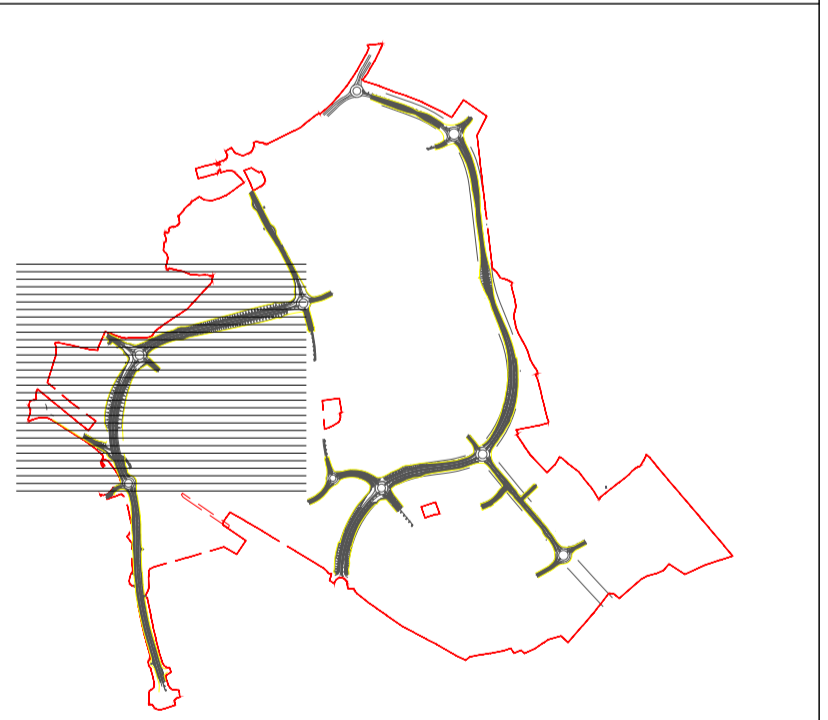
CLIENT: St James  
 PROJECT: Milton Keynes East - Trees  
 TITLE: Preliminary Tree Protection Plan - Highway Infrastructure (Sheet 2 of 7)  
 SCALE AT A3: 1:2000  
 DATE: March 2021  
 2090.83 / 40

(Green circle)	Canopy extent of tree: Category A
(Blue circle)	Canopy extent of tree: Category B
(Grey circle)	Canopy extent of tree: Category C
(Red circle)	Canopy extent of tree: Category U
