TRAFFMAP AccsMap - Accident Analysis System

Selected using Pre-defined Query: M1 inc 14, Northfield Rbt.

38748/1300/001 Rev A - Street Lighting (Sheet 1 of 2)

STAGE 1 ROAD SAFETY AUDIT RESPONSE REPORT

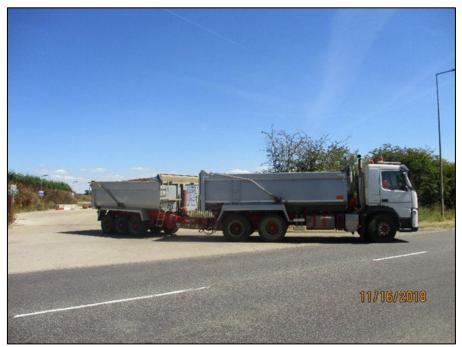
The proposals do not indicate any provision for the existing access to Caldecote Farm Sand and Gravel Works. Large vehicles use this access and currently all turning movements are permitted. The proposals will see Willen Road widened to 5 traffic lanes (3 northbound and 2 southbound) with central ghost-island hatching. There is no provision within the hatching for right turning vehicles to access to the sand and gravel works.

It is not clear how the scheme will accommodate vehicles turning right into and out from the sand and gravel works access. There will be conflict and risk of collision between right turning vehicles at the sand and gravel works and other traffic using the multiple lanes on Willen Road.

Willen Road - Large vehicle exiting from the sand and gravel works

The scheme proposals should recognise the existing access which is used by large / heavy vehicles. It is recommended that, in association with Problem 2.2 above, the sand and gravel works access is provided with a right turn lane or becomes left in / left out, with vehicles being able to U-turn at the Tongwell and the Marsh End Road roundabouts.

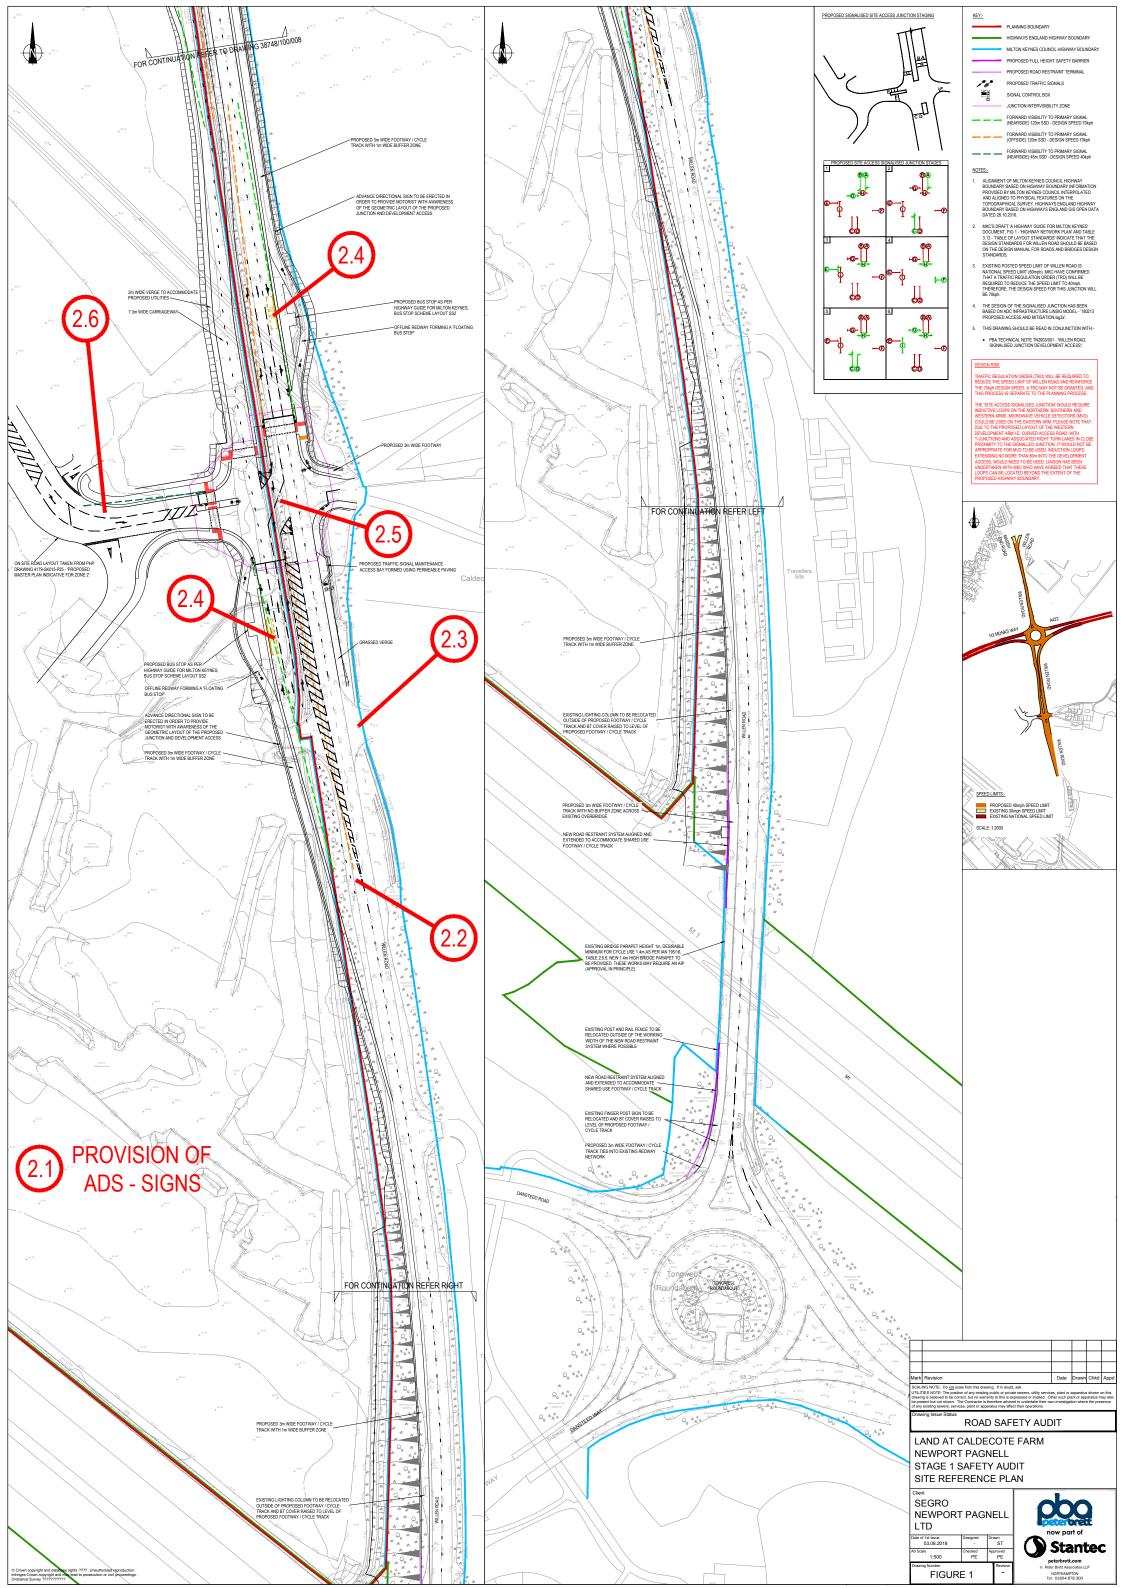
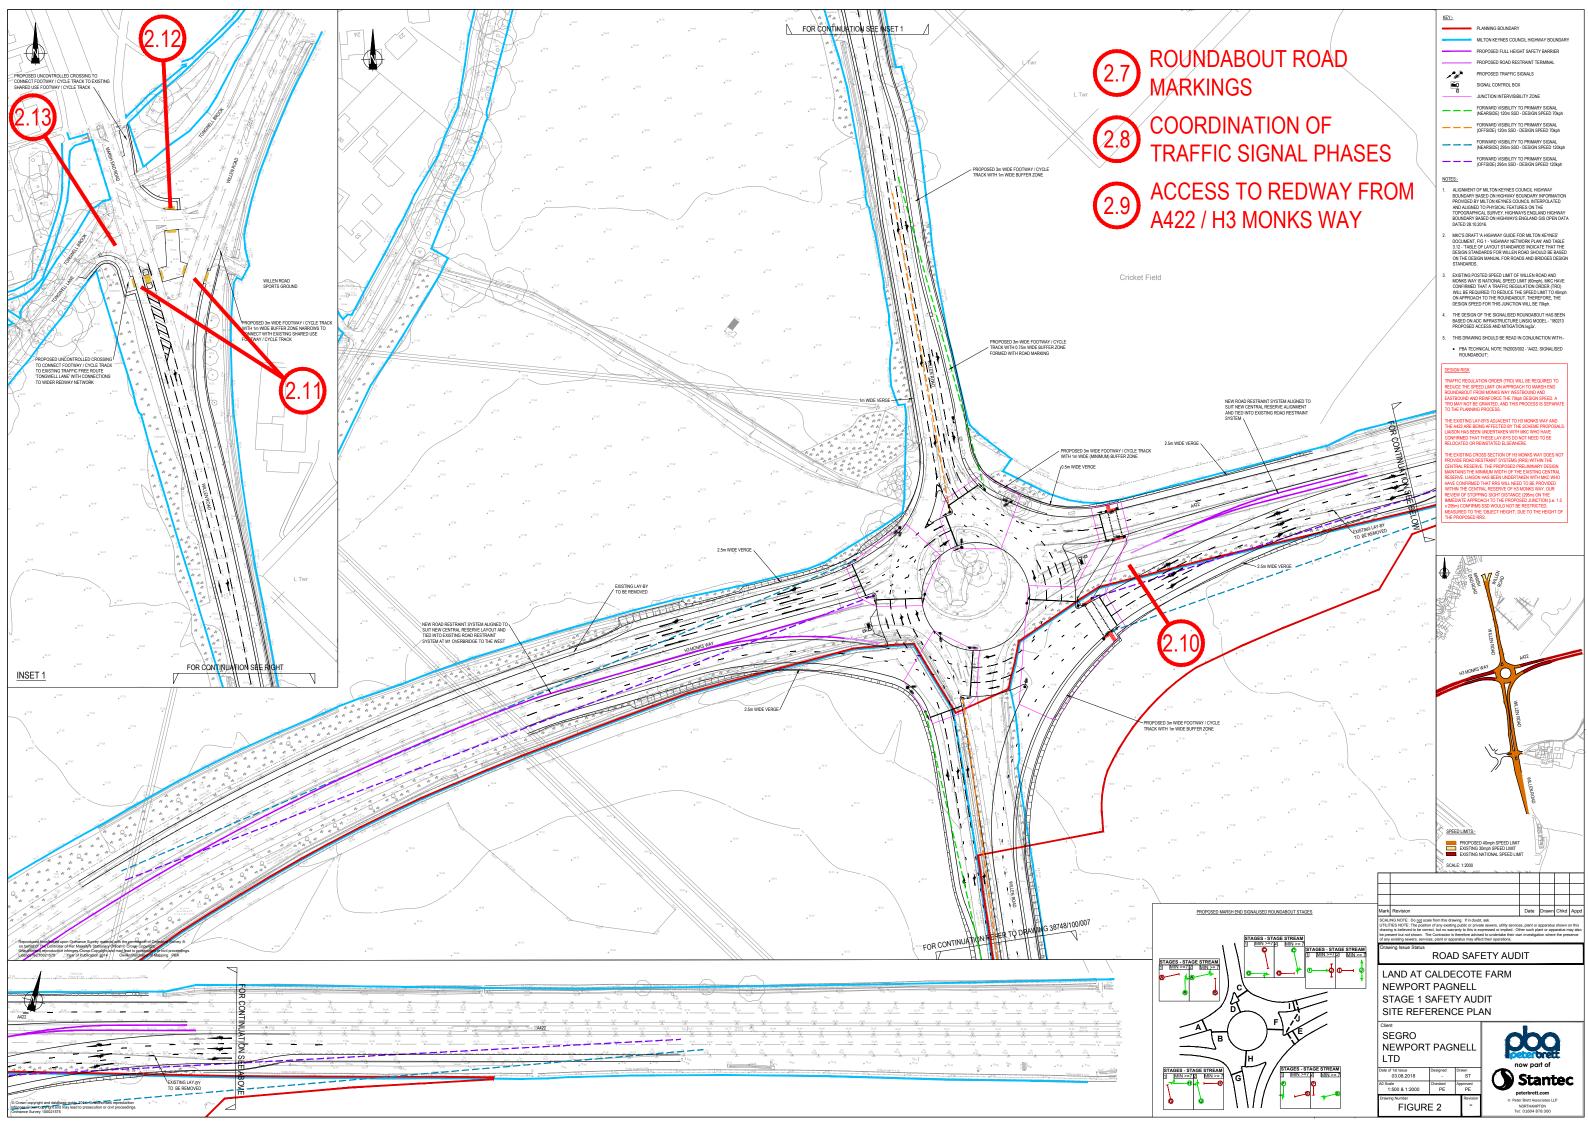
Figure 1 & Figure 2

Site Reference Plans

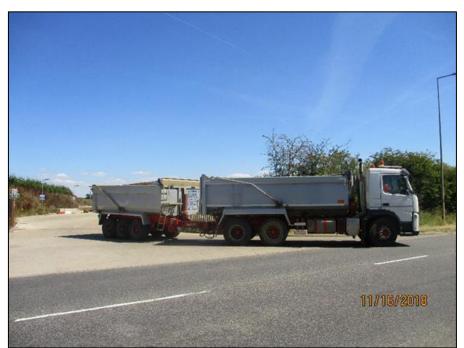
The proposals do not indicate any provision for the existing access to Caldecote Farm Sand and Gravel Works. Large vehicles use this access and currently all turning movements are permitted. The proposals will see Willen Road widened to 5 traffic lanes (3 northbound and 2 southbound) with central ghost-island hatching. There is no provision within the hatching for right turning vehicles to access to the sand and gravel works.

It is not clear how the scheme will accommodate vehicles turning right into and out from the sand and gravel works access. There will be conflict and risk of collision between right turning vehicles at the sand and gravel works and other traffic using the multiple lanes on Willen Road.

Willen Road – Large vehicle exiting from the sand and gravel works

The scheme proposals should recognise the existing access which is used by large / heavy vehicles. It is recommended that, in association with Problem 2.2 above, the sand and gravel works access is provided with a right turn lane or becomes left in / left out, with vehicles being able to U-turn at the Tongwell and the Marsh End Road roundabouts.
